**Flood Control Project Maintenance
Levee Inspections**
LMA District Cover Sheet
Spring 2018 Levee Inspection Results

Reclamation District No. 0017 Mossdale

Spring 2018 Levee Inspection Results

Waterway			Bank	Unit Miles
Unit No. 01 French Camp Slough			Left	1.76
	Spring (March - May)	Summer (June - August)	(September - November) Fall	Winter (December - February)
Unit Maintenance Rating (Fall Only)				
Date of Inspection	5/8/2018 - 5/8/2018			
DWR Inspector	Richard Willoughby			
Accompanied By	Richard Toy KSN			
	Scott Solari RD 17

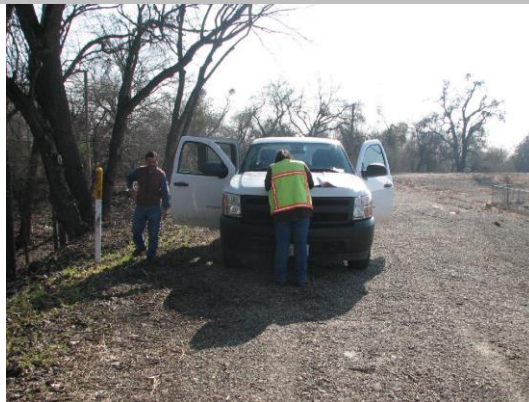
Photo 2 of 3 : UCIP_SP_2018_40603_38479.jpg

View of levee crown at crossing. Marker for line visible on waterward shoulder.

Comment Code						
Inspector Comment						
FS_ID:40603						
DS_ID:1						
EP_NO: 6623						
Repair Type: Non-Urgent						
Crossing Status: Found						
UCIP Comments: Marker missing on landward side. Need to contact owner to determine status of crossing. Need date of last inspection and confirmation that crossing is still in operable condition.						
FIELD_STRUCT_DESC: 5.563-inch welded steel natural gas pipeline through the levees, 4.5 feet below the crown, across the channels and overflow area. (5-inch gas line authorized under Permit No. 6623, 1969 - Laymac Corporation) [Additional Reference(s): DWR Levee Logs, 1981, 2003].						
FS Date: 2/3/2010

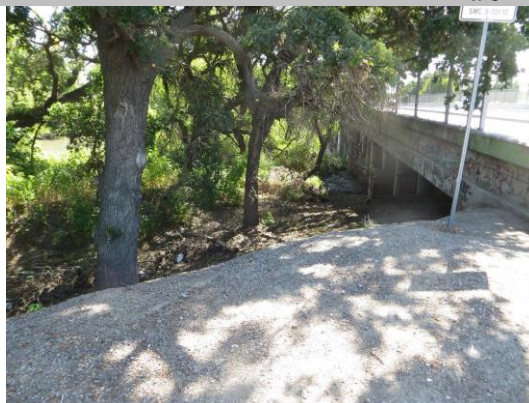
Photo 2 of 3 : UCIP_SP_2018_49990_74221.jpg

WS Slope. No gasline markers.

Comment Code						
Inspector Comment						
FS_ID:49990 DS_ID:72 EP_NO: 15185 Repair Type: Non-Urgent Crossing Status: Indicator Found UCIP Comments: 04/06/2018 Received supporting information from T. Marlow with KSN pertaining to line. PG&E has installed gas line distribution markers on both shoulder of the levee. Crossing is an active line. PG&E performs a leak survey at least twice a year according to Mr. R. Muok, Supervisor, Gas Pipeline Operations and Maintenance Stockton. Mr. Muok can be reached at 209-406-7926. Crossing has been downgraded from Urgent to Non-Urgent--pipe is inspected by owner. UCIP will need to coordinate with PG&E to obtain confirmation of inspections, obtain emergency contact information, and maintenance contact information. (DWR UCIP - O. Magana) 07/12/2016 No markers (no photos taken in 2016). Need to contact owner to determine status of crossing. If crossing is active, owner will need to coordinate with CVFPB to install markers to comply with Title 23. (DWR UCIP - omagana)5/19/2015 Need to install gasline markers. (DWR UCIP - omagana) FIELD_STRUCT_DESC: 8-inch soil proofed steel gas main through the left bank levee and under the channel of French Camp Slough. The pipeline has a minimum cover of 20 to 25 feet within the overflow areas and under the channel. (8-inch line authorized under Permit No. 15185, 1989 - Pacific Gas & Electric Company [PG&E]) FS Date: 7/12/2016

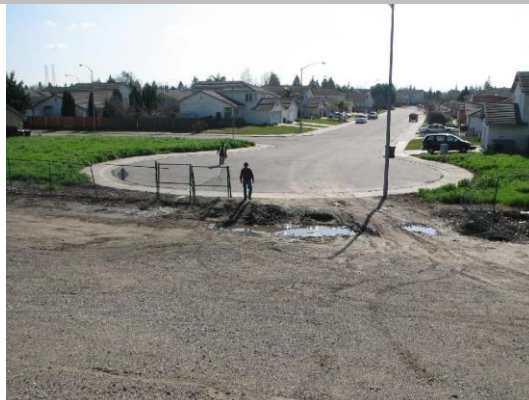
Photo 2 of 3 : UCIP_SP_2018_40604_38489.jpg

View of landward side.

Comment Code						
Inspector Comment						
FS_ID:40604						
DS_ID:2						
EP_NO: 14992						
Repair Type: Non-Urgent						
Crossing Status: Indicator Found						
UCIP Comments: Need to contact owner to determine status of crossing. Also need date of last inspection.						
FIELD_STRUCT_DESC: [Weston Ranch - French Camp Slough Crossings] 1 of 3. 30-inch high-density polyethylene (HDPE) sewer force main (SFM) through the levee, 32 feet below levee crown. All pipes encased in concrete. (two 30-inch force mains (originally issued as 27-inch) and one 12-inch pipe authorized under Permit No. 14992, 1989 - City of Stockton and Richard Blewett) [Additional Reference(s): DWR Levee Logs, 1981, 2003]						
FS Date: 2/3/2010

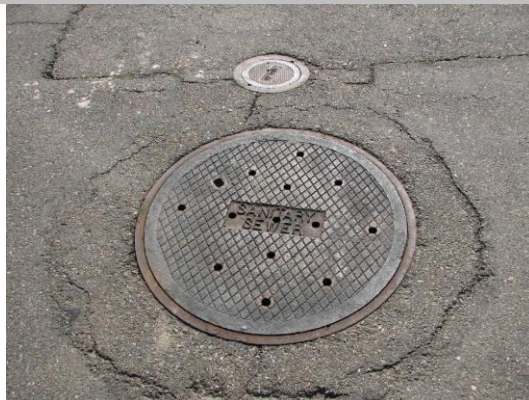
Photo 3 of 3 : UCIP_SP_2018_52614_38509.jpg

Manhole for sanitary sewer visible on landward side.

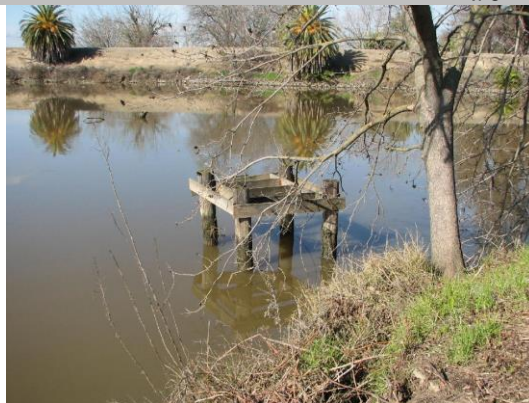
Photo 2 of 3 : UCIP_SP_2018_40628_38515.jpg

Comment Code						
Inspector Comment						
FS_ID:40628 DS_ID:75 EP_NO: 15093 Repair Type: Non-Urgent Crossing Status: Found UCIP Comments: Only appurtenances remaining at this location--4 pillings located on waterward side. According to records the pillings were to be removed under a completion maintenace contract. Need to coordinate with owner. FIELD_STRUCT_DESC: 14-inch-diameter pipeline through levee at unknown depth. Per inspector's notes "this crossing is abandoned almost all materials removed including pipes, conduit, and pump house. The only items left are 4 pilings which are to be removed under a completion maintenance contract. Approximately 200 feet of reinforced concrete pipe lateral removed in R/W south of crossing". FS Date: 2/3/2010

View of waterward side--pillings inside channel.

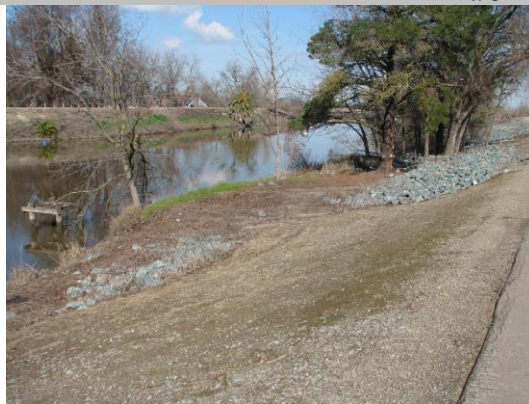
Photo 3 of 3 : UCIP_SP_2018_40628_38514.jpg

View of waterward side.

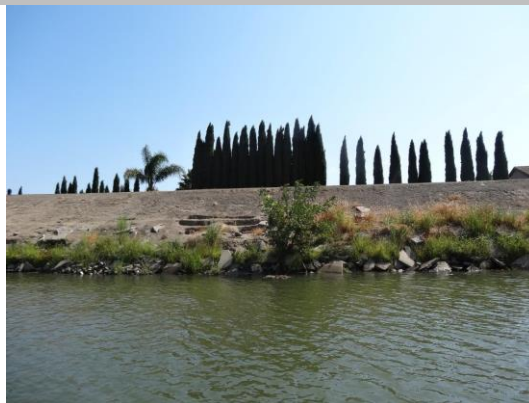
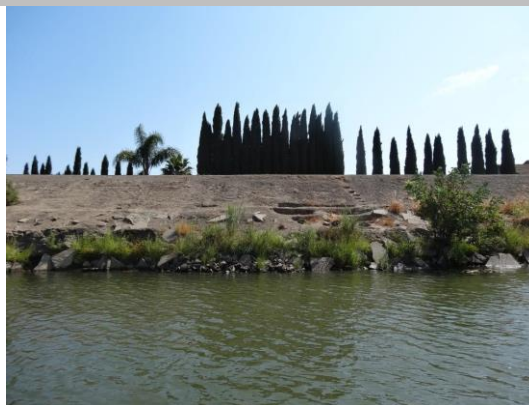
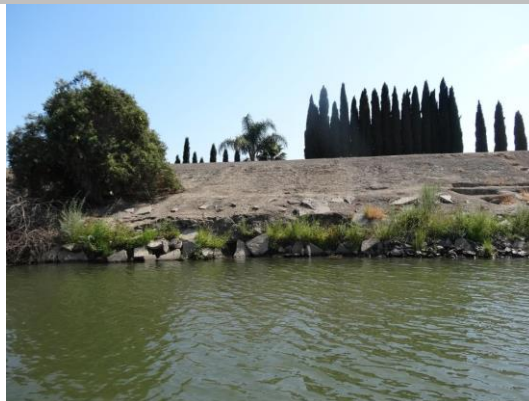
LM Start	0.25	Rating **	M	Issue No.	2 (cont)
LM End	0.26	Issue Type +	Ma	Location *	WS

Front view of the erosion.

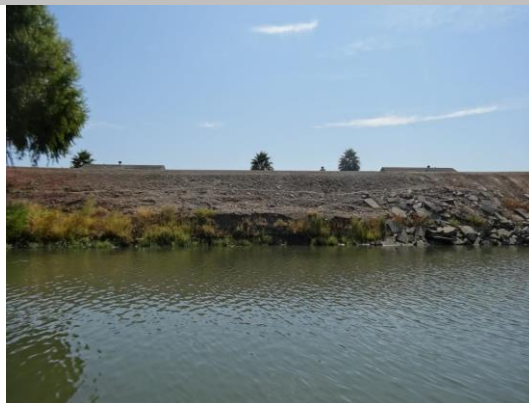
Photo 1 of 3 : SP_2018_RD0017_304_3_20180323_00007.jpg

LM Start	0.91	Rating **	M	Issue No.	3
LM End	0.91	Issue Type +	Ma	Location *	WS
Category	Supplemental			GPS Latitude/Longitude	
				Start	End
Item	DWR Erosion Survey			37.904310 °	37.904310 °
				-121.323386 °	-121.323386 °
DWR ID	RD0017U02RM44.14				
Comment Code					
Inspector Comment					
09/13/2017: The erosion is located upstream of a big tree. [2017 Site ID:RD0017U02RM44.14]

Front view of the erosion.

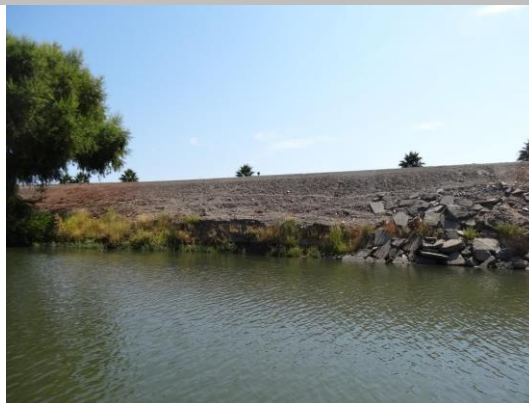
Photo 2 of 3 : SP_2018_RD0017_304_3_20180323_00008.jpg

Front view of the erosion.

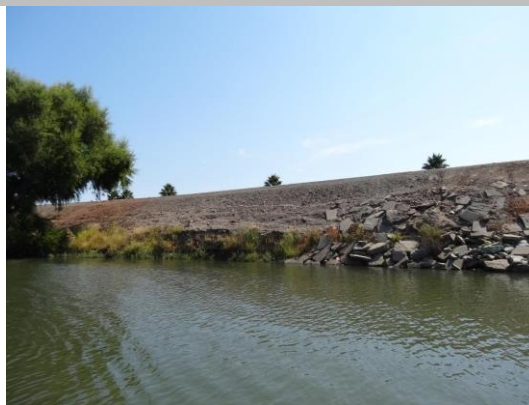
Photo 3 of 3 : SP_2018_RD0017_304_3_20180323_00009.jpg

Looking downstream at the erosion.

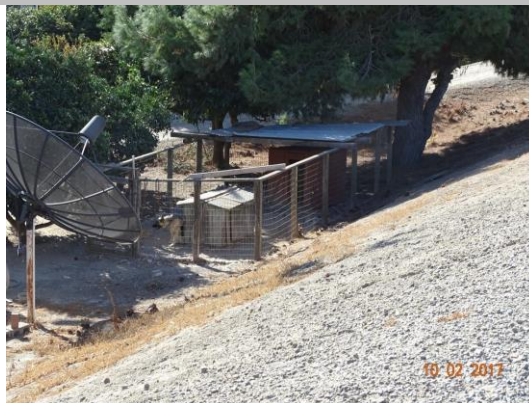
Photo 1 of 1 : SP_2018_RD0017_304_73_20180323_00012.jpg

LM Start	1.13	Rating **	M	Issue No.	73
LM End	1.13	Issue Type +	En	Location *	LS
Category	Earthen Levee			GPS Latitude/Longitude	
				Start	End
Item	Encroachments			37.901693 °	37.901693 °
				-121.325582 °	-121.325582 °
DWR ID	DWR_RD0017_02_s_2017_73				
Comment Code					
BU : Building					
Inspector Comment

Looking southeast at the landside slope.

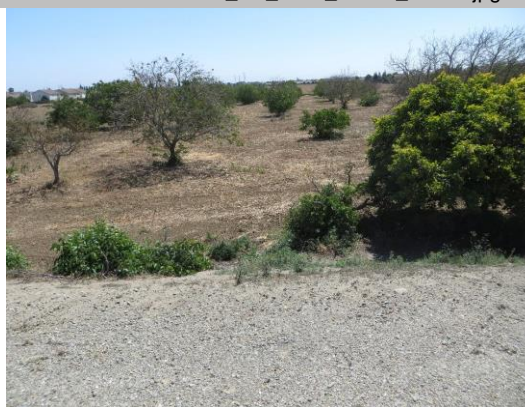
Photo 2 of 2 : UCIP_SP_2018_45450_74106.jpg

No markers on LS.

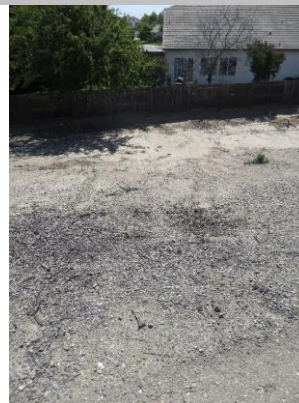
Photo 2 of 2 : UCIP_SP_2018_49637_74108.jpg

View of LS. No appurtenances noted.

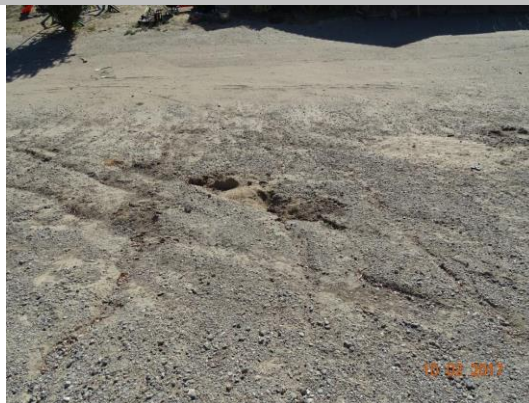
Photo 1 of 1 : SP_2018_RD0017_304_70_20180323_00011.jpg

Looking east at the landside slope.

LM Start	1.43	Rating **	M	Issue No.	70
LM End	1.43	Issue Type +	Ma	Location *	LS
Category	Earthen Levee			GPS Latitude/Longitude	
				Start	End
Item	Slope Stability			37.897508 °	37.897508 °
				-121.326671 °	-121.326671 °
DWR ID	DWR_RD0017_02_f_2017_70				
Comment Code					
S3 : Repair the levee slope damaged by vehicle traffic and prevent access where possible.					
Inspector Comment

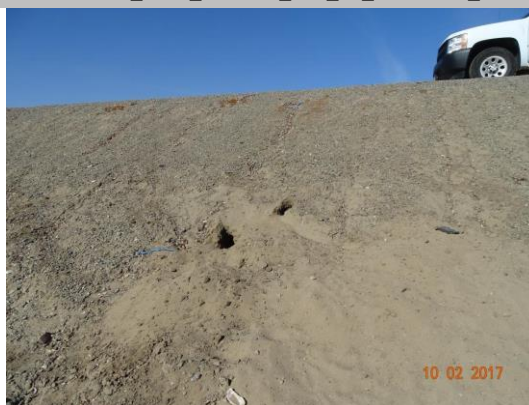
Photo 1 of 1 : SP_2018_RD0017_304_75_20180323_00013.jpg

Looking west at the landside slope.

LM Start	1.43	Rating **	M	Issue No.	75
LM End	1.43	Issue Type +	Ma	Location *	LS
Category	Earthen Levee			GPS Latitude/Longitude	
				Start	End
Item	Animal Control			37.897467 °	37.897467 °
				-121.326690 °	-121.326690 °
DWR ID	DWR_RD0017_02_f_2017_75				
Comment Code					
A3 : No rodents visible, but rodent burrows visible; need to backfill and compact or grout burrows.					
Inspector Comment

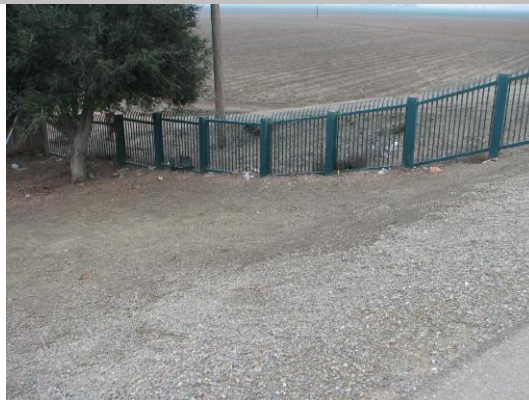
Photo 2 of 3 : UCIP_SP_2018_40639_38686.jpg

View of landward side.

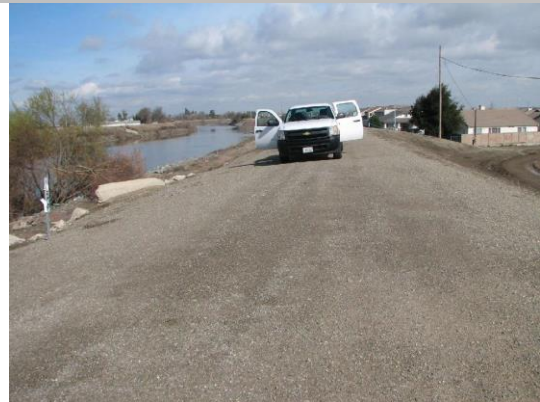
Photo 1 of 3 : UCIP_SP_2018_40640_71981.jpg

Comment Code					
Inspector Comment					
FS_ID:40640					
DS_ID:12					
EP_NO: 15099					
Repair Type: Non-Urgent					
Crossing Status: Found					
UCIP Comments: Need to coordinate with owner to determine status of crossing. If crossing is no longer in use owner will need to contact the CVFPB to comply with Title 23.					
FIELD_STRUCT_DESC: 16-inch steel irrigation pipe through levee, 2.30 feet below levee crown. Siphon breaker on waterside (WS) shoulder. Pump house located on the WS berm. Standpipe located 15 feet from landside (LS) toe. Concrete stairway on WS slope. (16-inch pipe removed under Permit No. 15099, 1989 - W. Long, 12-inch pipe removed) [Additional Reference(s): DWR Levee Logs, 1981, 2003]					
FS Date: 2/4/2010

View of levee crown at crossing.

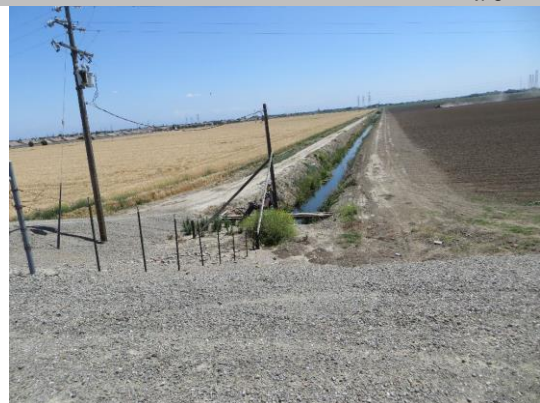
Photo 2 of 3 : UCIP_SP_2018_49640_74437.jpg

(2015) Damage pipe section located on WS toe has been replaced.

(2015) View of landward side.

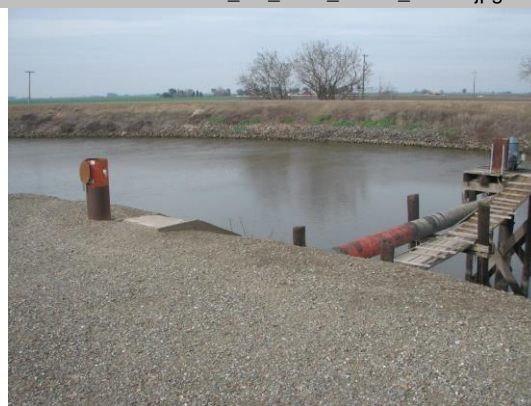
Photo 3 of 3 : UCIP_SP_2018_40645_72006.jpg

Comment Code						
Inspector Comment						
FS_ID:40645 DS_ID:16 EP_NO: 15102 Repair Type: Non-Urgent Crossing Status: Found UCIP Comments: Need to coordinate with owner to determine status of crossing. FIELD_STRUCT_DESC: 20-inch steel irrigation pipeline through levee. Invert of pipe is 2.8 feet below levee crown. Fill placed over the pipeline to provide 2.0 feet of cover. Siphon breaker on waterside (WS) shoulder. Pump on platform with walkway to shoulder, standpipe located 15 feet landside (LS) toe, concrete stairway en waterside (WS) slope. (20-inch pipe installed under Permit No. 15102, 1990 - Calcagno Farms Co-Partnership, also 24-inch pipe removed; 20-inch pipe was installed during the levee work approved under Permit No. 15014, 1989 - Reclamation District 17 [RD0017])). [Additional Reference(s): DWR Levee Logs, 1981, 2003] FS Date: 2/4/2010

Overview of waterward side.

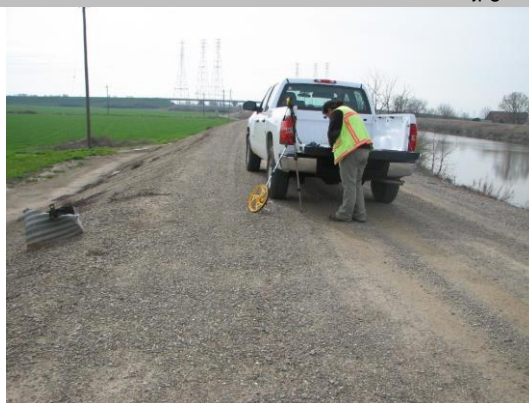
Photo 2 of 3 : UCIP_SP_2018_40646_72009.jpg

FS_ID:40646
DS_ID:17
EP_NO: 15103
Repair Type: Non-Urgent
Crossing Status: Found
UCIP Comments: Need to coordinate with owner to determine status of crossing. If crossing is no longer in use owner will need to contact the CVFPB to comply with Title 23.
FIELD_STRUCT_DESC: 8-inch steel irrigation pipe through levee. Invert of pipe is 3.47 feet below crown. Siphon breaker on landside (LS) shoulder. Pump house on waterside (WS) slope, standpipe located 10 feet from LS toe. Concrete stairway on WS slope. (new 8-inch authorized under Permit No. 15103, 1990 - C. Young, existing 8-inch pipe removed; new 8-inch pipe was installed during the levee work approved under Permit No. 15014) [Additional Reference(s): DWR Levee Logs, 1981, 2003]
FS Date: 2/4/2010

View of levee crown at crossing.

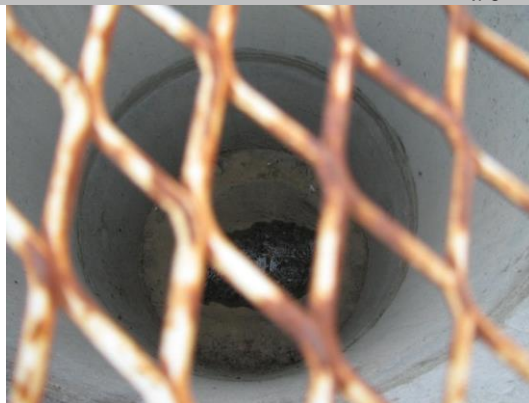
Photo 3 of 3 : UCIP_SP_2018_40646_72008.jpg

Comment Code						
Inspector Comment						
FS_ID:40646						
DS_ID:17						
EP_NO: 15103						
Repair Type: Non-Urgent						
Crossing Status: Found						
UCIP Comments: Need to coordinate with owner to determine status of crossing. If crossing is no longer in use owner will need to contact the CVFPB to comply with Title 23.						
FIELD_STRUCT_DESC: 8-inch steel irrigation pipe through levee. Invert of pipe is 3.47 feet below crown. Siphon breaker on landside (LS) shoulder. Pump house on waterside (WS) slope, standpipe located 10 feet from LS toe. Concrete stairway on WS slope. (new 8-inch authorized under Permit No. 15103, 1990 - C. Young, existing 8-inch pipe removed; new 8-inch pipe was installed during the levee work approved under Permit No. 15014) [Additional Reference(s): DWR Levee Logs, 1981, 2003]						
FS Date: 2/4/2010

Inside view of standpipe located on landward side.

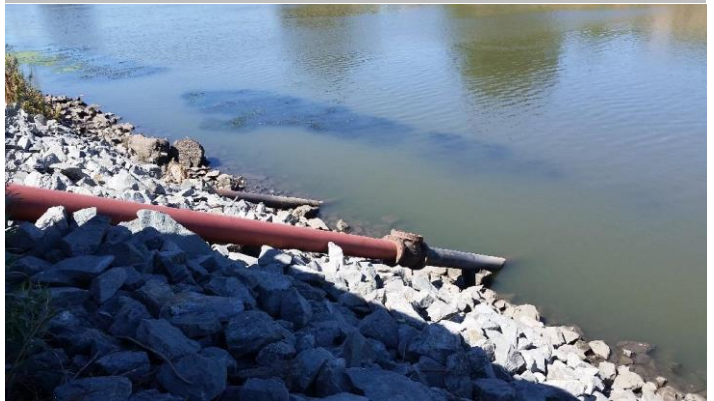
Photo 1 of 3 : UCIP_SP_2018_49993_75736.jpg

FS_ID:49993
DS_ID:278
EP_NO: 15104
Repair Type: Urgent
Crossing Status: Found
UCIP Comments: 7/12/2016 Same as previous inspection. Holes visible along exposed WS section of pipe. (DWR UCIP - omagana)5/19/2015 Holes through pipe visible on waterward toe. Recommend contacting owner to confirm pipe use--good candidate for internal inspection. (DWR UCIP - omagana)2/04/2010 Need to coordinate with owner to determine status of crossing. If crossing is no longer in use owner will need to contact the CVFPB to comply with Title 23. (DWR UCIP - omagana)
FIELD_STRUCT_DESC: 8-inch steel irrigation pipe through the levee, 2.85 feet below levee crown. Pump station is located on waterside (WS). Concrete standpipe is located on the landside (LS) toe. (8-inch pipe authorized under Permit No. 15104, 1989-R. Romonda & C. Young, permit covers 4 pipe crossing removals and 3 new pipe installations; levee re-shaping authorized under Permit No. 15014, 1989 - Reclamation District 17 [RD0017]; pipe was installed as part of the re-shaping of RD17 project levees in 1989. The re-shaping of the levees was to increase levee elevations and provide freeboard above 100-year stages in both the San Joaquin River and French Camp Slough) [Additional Reference(s): DWR Levee Log, 1981 and 2003]

View of WS, photo taken downstream looking at upstream pipe. Photo 1 of 2.

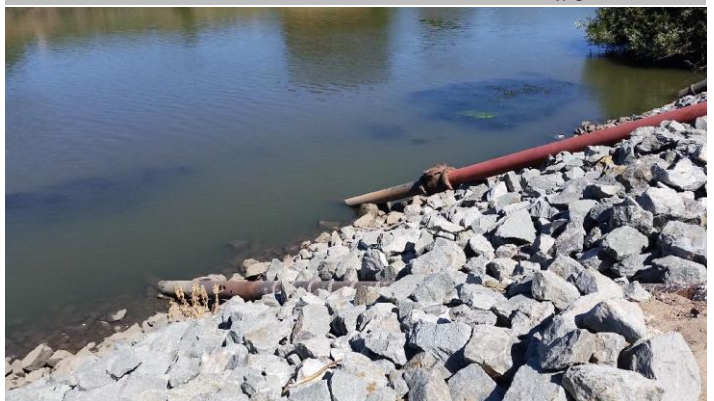
Photo 2 of 3 : UCIP_SP_2018_49993_75733.jpg

View of WS, photo taken upstream looking at first pipe. Photo 1 of 2.

FS_ID:49993
DS_ID:278
EP_NO: 15104
Repair Type: Urgent
Crossing Status: Found
UCIP Comments: 7/12/2016 Same as previous inspection. Holes visible along exposed WS section of pipe. (DWR UCIP - omagana)5/19/2015 Holes through pipe visible on waterward toe. Recommend contacting owner to confirm pipe use--good candidate for internal inspection. (DWR UCIP - omagana)2/04/2010 Need to coordinate with owner to determine status of crossing. If crossing is no longer in use owner will need to contact the CVFPB to comply with Title 23. (DWR UCIP - omagana)
FIELD_STRUCT_DESC: 8-inch steel irrigation pipe through the levee, 2.85 feet below levee crown. Pump station is located on waterside (WS). Concrete standpipe is located on the landside (LS) toe. (8-inch pipe authorized under Permit No. 15104, 1989-R. Romonda & C. Young, permit covers 4 pipe crossing removals and 3 new pipe installations; levee re-shaping authorized under Permit No. 15014, 1989 - Reclamation District 17 [RD0017]; pipe was installed as part of the re-shaping of RD17 project levees in 1989. The re-shaping of the levees was to increase levee elevations and provide freeboard above 100-year stages in both the San Joaquin River and French Camp Slough) [Additional Reference(s): DWR Levee Log, 1981 and 2003]

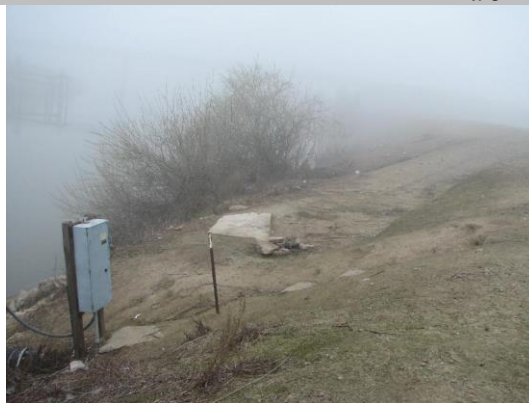
Photo 1 of 3 : UCIP_SP_2018_40655_72050.jpg

FS_ID:40655
DS_ID:20
EP_NO: 15106
Repair Type: Non-Urgent
Crossing Status: Found
UCIP Comments: Burrow activity dession on landward slope. Need to coordinate with owner to determine status of crossing. If crossing is no longer in use owner will need to contact the CVFPB to comply with Title 23.
FIELD_STRUCT_DESC: 10-inch steel irrigation pipe through levee, 3.27 feet below levee crown. Siphon breaker on landside (LS) shoulder. Pump on waterside (WS) slope, standpipe located 14 feet LS of levee toe. (10-inch installed and existing 12-inch pipe removed under Permit No. 15106, 1989-A.J. Rodgers Estate - C/O Opal Rodgers; pipe was installed during the levee work approved under Permit Number 15014, 1989-Reclamation District No. 17 [RD0017]) [Additional Reference(s): DWR Levee Logs, 1981, 2003]
FS Date: 2/4/2010

View of waterward side.

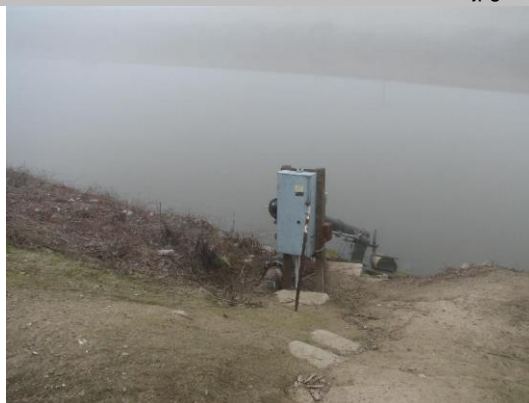
Photo 2 of 3 : UCIP_SP_2018_40655_72051.jpg

Pump station and control panel located on waterward side.

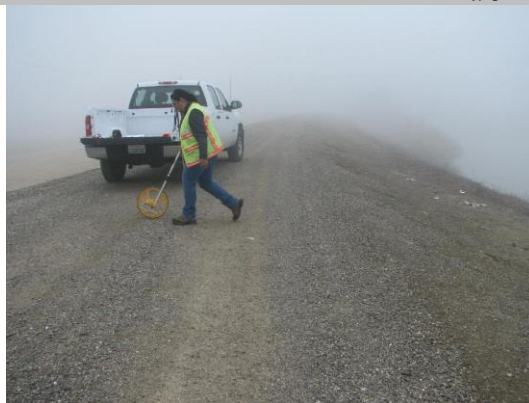
Photo 3 of 3 : UCIP_SP_2018_40655_72049.jpg

Comment Code					
Inspector Comment					
FS_ID:40655 DS_ID:20 EP_NO: 15106 Repair Type: Non-Urgent Crossing Status: Found UCIP Comments: Burrow activity dession on landward slope. Need to coordinate with owner to determine status of crossing. If crossing is no longer in use owner will need to contact the CVFPB to comply with Title 23. FIELD_STRUCT_DESC: 10-inch steel irrigation pipe through levee, 3.27 feet below levee crown. Siphon breaker on landside (LS) shoulder. Pump on waterside (WS) slope, standpipe located 14 feet LS of levee toe. (10-inch installed and existing 12-inch pipe removed under Permit No. 15106, 1989-A.J. Rodgers Estate - C/O Opal Rodgers; pipe was installed during the levee work approved under Permit Number 15014, 1989-Reclamation District No. 17 [RD0017]) [Additional Reference(s): DWR Levee Logs, 1981, 2003] FS Date: 2/4/2010

View of levee crown at crossing.

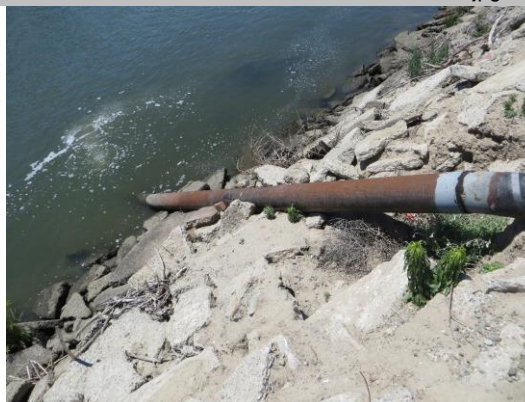
Photo 2 of 3 : UCIP_SP_2018_46005_74458.jpg

(2015) Pipe section replaced.

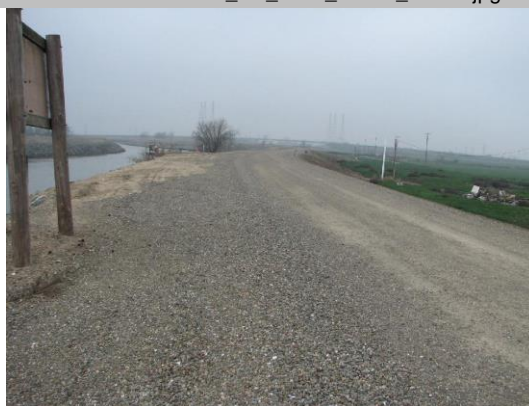
Photo 1 of 3 : UCIP_SP_2018_40658_72112.jpg

Comment Code						
Inspector Comment						
FS_ID:40658 DS_ID:23 EP_NO: 4116 Repair Type: Non-Urgent Crossing Status: Found UCIP Comments: Need to contact owner to determine status of crossing. Need date of last inspection and confirmation that crossing is still in operable condition. FIELD_STRUCT_DESC: 8.625-inch steel high pressure gas main through the levee. Invert of pipe is 3.9 feet below the crown. Location sign for gas pipeline crossing on waterside (WS) slope. PG&E contact information 510-779-4830 for crossing. (8.625-inch gas main authorized under Permit No. 4116, 1962-Pacific Gas and Electric Company [PG&E]) [Additional Reference(s): DWR Levee Logs, 1981, 2003] FS Date: 2/4/2010

View of levee crown at crossing.

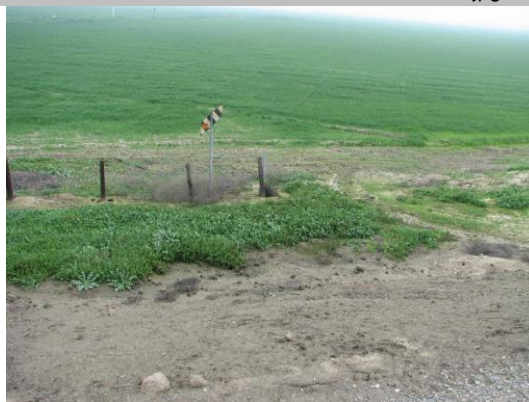
Photo 2 of 3 : UCIP_SP_2018_40658_72111.jpg

View of landward side.

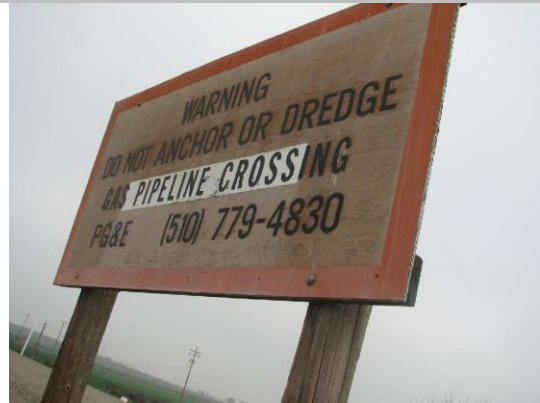
Photo 3 of 3 : UCIP_SP_2018_40658_72110.jpg

Comment Code						
Inspector Comment						
FS_ID:40658						
DS_ID:23						
EP_NO: 4116						
Repair Type: Non-Urgent						
Crossing Status: Found						
UCIP Comments: Need to contact owner to determine status of crossing. Need date of last inspection and confirmation that crossing is still in operable condition.						
FIELD_STRUCT_DESC: 8.625-inch steel high pressure gas main through the levee. Invert of pipe is 3.9 feet below the crown. Location sign for gas pipeline crossing on waterside (WS) slope. PG&E contact information 510-779-4830 for crossing. (8.625-inch gas main authorized under Permit No. 4116, 1962-Pacific Gas and Electric Company [PG&E]) [Additional Reference(s): DWR Levee Logs, 1981, 2003]						
FS Date: 2/4/2010

Marker visible on waterward side.

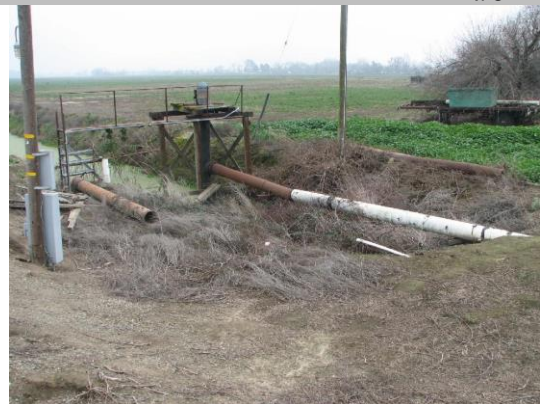
Photo 1 of 3 : UCIP_SP_2018_40659_72116.jpg

LM Start	3.63	Rating **	M	Issue No.	106
LM End	3.63	Issue Type +	En	Location *	
Category	Supplemental			GPS Latitude/Longitude	
				Start	End
Item	DWR UCIP Field Study			37.868657 °	37.868657 °
				-121.327383 °	-121.327383 °
DWR ID					
Comment Code					
Inspector Comment					
FS_ID:40659 DS_ID:26 EP_NO: 15109 Repair Type: Non-Urgent Crossing Status: Found UCIP Comments: Erosion around siphon breaker on landward side recommend investigating potential leak. FIELD_STRUCT_DESC: 12-inch steel drainage pipe through levee, 3 feet below levee crown. Siphon breaker on landside (LS) shoulder. Pump in irrigation ditch is located about 45 feet from LS toe. (12-inch pipe authorized under Permit No. 15109, 1990 - R. Muller) [Additional Reference(s): DWR Levee Logs, 1981, 2003] FS Date: 2/4/2010

View of pipe section and pump station located on landward side.

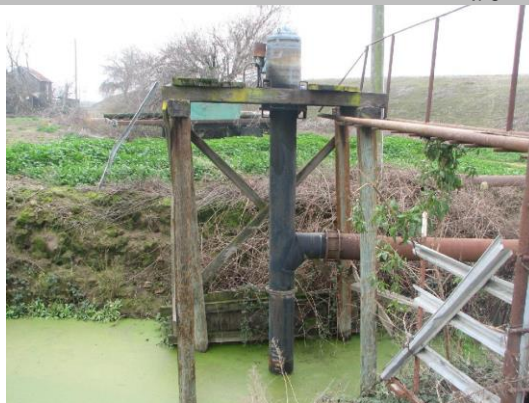
Photo 2 of 3 : UCIP_SP_2018_40659_72115.jpg

Pump station locate on landward side.

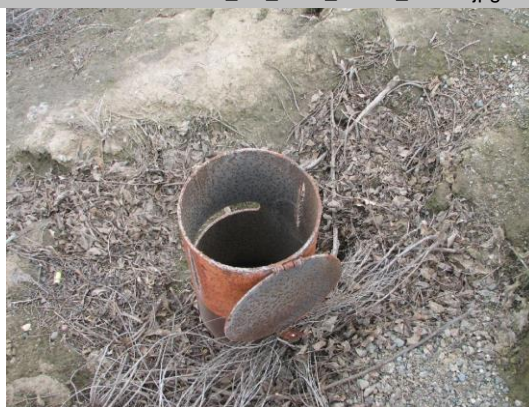
Photo 3 of 3 : UCIP_SP_2018_40659_72114.jpg

Siphon breaker located on landward slope.

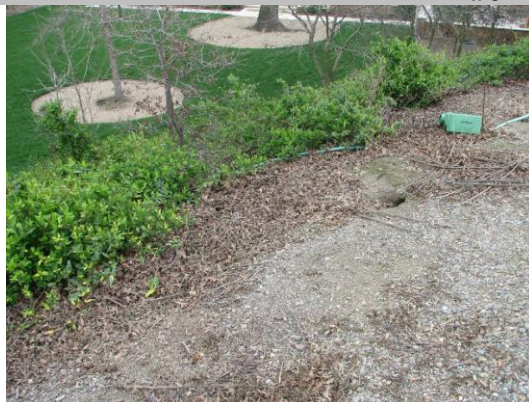
Photo 2 of 3 : UCIP_SP_2018_43264_72124.jpg

View of landward side.

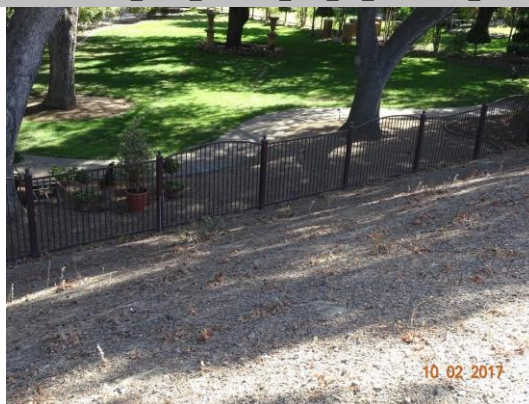
Photo 1 of 1 : SP_2018_RD0017_304_79_20180323_00014.jpg

LM Start	4.23	Rating **	M	Issue No.	79
LM End	4.28	Issue Type +	En	Location *	LS
Category	Earthen Levee			GPS Latitude/Longitude	
				Start	End
Item	Encroachments			37.863494 °	37.862935 °
				-121.320158 °	-121.319798 °
DWR ID	DWR_RD0017_02_f_2017_79				
Comment Code					
FE : Fence					
Inspector Comment					
Fence along landside toe limiting access.

Looking east at the landside slope.

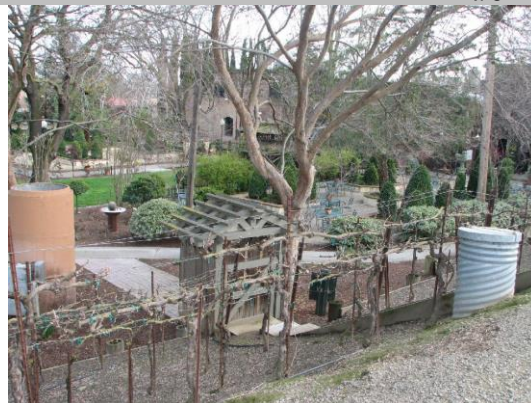
Photo 1 of 3 : UCIP_SP_2018_40662_72130.jpg

Comment Code					
Inspector Comment					
FS_ID:40662 DS_ID:29 EP_NO: 15112 Repair Type: Non-Urgent Crossing Status: Found UCIP Comments: Need to coordinate with owner to determine status of crossing. If crossing is no longer in use owner will need to contact the CVFPB to comply with Title 23. Debris (pipe section) scattered on waterward side. FIELD_STRUCT_DESC: 10-inch steel irrigation pipe through levee, 3.29 feet below crown. Siphon breaker on landside (LS) shoulder. Pump on waterside (WS) berm, standpipe located 28 feet from the LS toe. Stairway located on both WS and LS slopes. (10-inch pipe installed and existing 10-inch pipe removed under Permit No. 15112, 1990 - C. Marshall; 10-inch pipe was installed during the levee work approved under Permit No. 15014, 1989 - Reclamation District 17 [RD0017]) [Additional Reference(s): DWR Levee Logs, 1981 and 2003] FS Date: 2/4/2010

View of landward side.

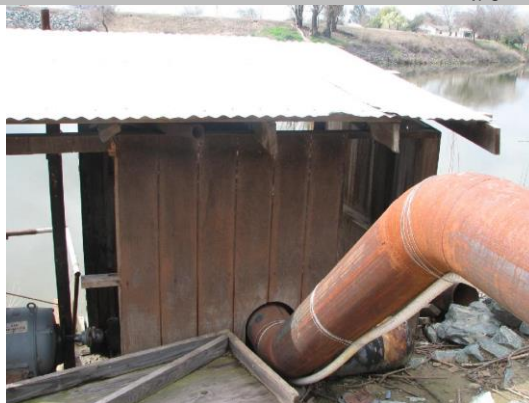
Photo 3 of 3 : UCIP_SP_2018_40662_72134.jpg

Comment Code						
Inspector Comment						
FS_ID:40662 DS_ID:29 EP_NO: 15112 Repair Type: Non-Urgent Crossing Status: Found UCIP Comments: Need to coordinate with owner to determine status of crossing. If crossing is no longer in use owner will need to contact the CVFPB to comply with Title 23. Debris (pipe section) scattered on waterward side. FIELD_STRUCT_DESC: 10-inch steel irrigation pipe through levee, 3.29 feet below crown. Siphon breaker on landside (LS) shoulder. Pump on waterside (WS) berm, standpipe located 28 feet from the LS toe. Stairway located on both WS and LS slopes. (10-inch pipe installed and existing 10-inch pipe removed under Permit No. 15112, 1990 - C. Marshall; 10-inch pipe was installed during the levee work approved under Permit No. 15014, 1989 - Reclamation District 17 [RD0017]) [Additional Reference(s): DWR Levee Logs, 1981 and 2003] FS Date: 2/4/2010

Pipe through pump house located on waterward side.

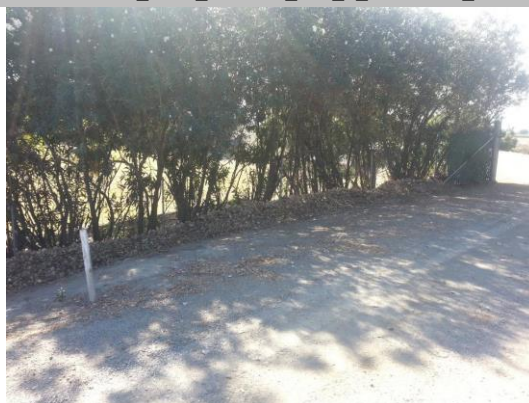
Photo 1 of 2 : SP_2018_RD0017_304_1_20180323_00001.jpg

LM Start	4.37	Rating **	A/W	Issue No.	1
LM End	4.39	Issue Type +	En	Location *	LS
Category	Earthen Levee			GPS Latitude/Longitude	
				Start	End
Item	Vegetation			37.861673 °	37.861370 °
				-121.320115 °	-121.320102 °
DWR ID	DWR_RD0017_02_s_2012_1				
Comment Code					
V6 : Landscaping					
Inspector Comment					
Oleander along fence line. LMA trimmed oleander along landside.

Looking south at trimmed oleanders on landward slope along fence.

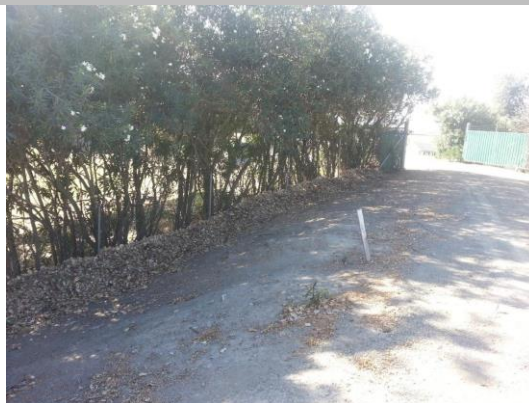
Photo 2 of 2 : SP_2018_RD0017_304_1_20180323_00002.jpg

LM Start	4.37	Rating **	A/W	Issue No.	1 (cont)	
LM End	4.39	Issue Type +	En	Location *	LS	
Category	Earthen Levee			GPS Latitude/Longitude		
				Start	End	
Item	Vegetation			37.861673 °	37.861370 °	
				-121.320115 °	-121.320102 °	
DWR ID	DWR_RD0017_02_s_2012_1					
Comment Code						
V6 : Landscaping						
Inspector Comment						
Oleander along fence line. LMA trimmed oleander along landside.

Looking southwest at trimmed oleanders on landward slope along fence.

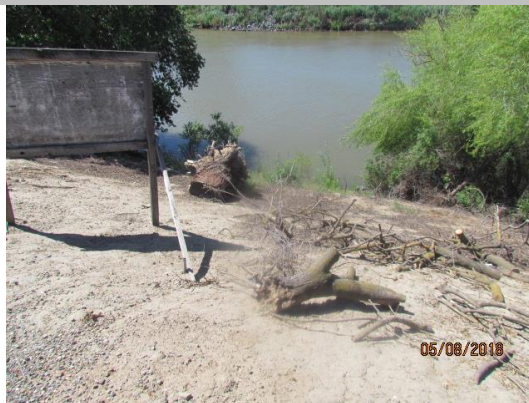
Photo 1 of 1 : SP_2018_RD0017_304_86_20180511_00197.jpg

LM Start	4.49	Rating **	M	Issue No.	86
LM End	4.49	Issue Type +	En	Location *	WS
Category	Earthen Levee			GPS Latitude/Longitude	
				Start	End
Item	Encroachments			37.860728 °	37.860728 °
				-121.318529 °	-121.318529 °
DWR ID	DWR_RD0017_02_s_2018_86				
Comment Code					
TR : Tree or limb					
Inspector Comment

Looking southwest at tree stump and tree limbs on waterward slope.
(Spring 2018)

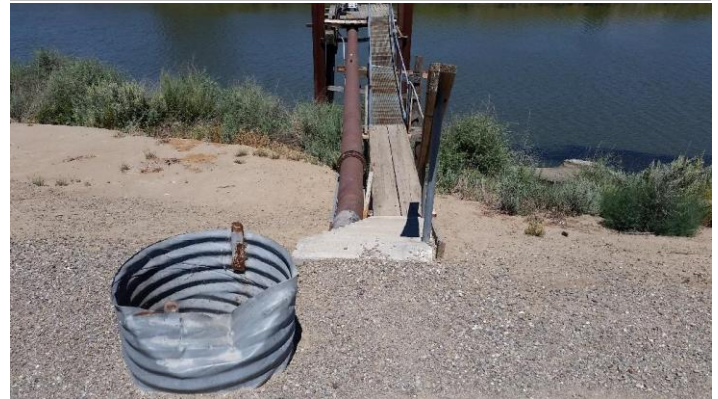
Photo 1 of 3 : UCIP_SP_2018_52574_75723.jpg

FS_ID:52574
DS_ID:33
EP_NO: 15116
Repair Type: Urgent
Crossing Status: Found
UCIP Comments: 12/01/2017 Inspection update is based on supporting documentation provided by KSN Inc, R. Toy, on November 18, 2016. Levee slope repair was performed on the LS slope area. Crossing remains Urgent--internal erosion visible from WS where pipe daylights has not been addressed. Recommend internal inspection of pipe through the levee to determine pipe condition. (DWR UCIP - o. magana) 7/12/2016 Same as last inspection--internal erosion on WS and LS slope slipping with visible head scarp. Internal erosion visible from WS where pipe daylights. LS slope slipping with visible head scarp approximately 6-inches. Need to coordinate with owner to address issue. Owner will need to work with DWR Inspector and CVFPB to comply with Title 23 requirements. Recommend internal integrity inspection of crossing to determine pipe condition through levee. (DWR UCIP - omagana)5/19/2015 Signs of internal erosion visible on waterward side where pipe daylights. Slope slumping visible on landward side where previous levee damage was present. Need to contact owner and KSN, LMA engineering firm, to coordinate potential issues with pipe. (DWR UCIP - omagana)2/04/2010 Pipe failure--internal erosion visible on waterward and landward side. Recommend LMA superintendent notify owner to stop using crossing to avoid further damage to levee slope. Owner will need to coordinate with DWR Inspector and CVFPB to address pipe failure per Title 23 requirements. (DWR UCIP - omagana)

View of WS.

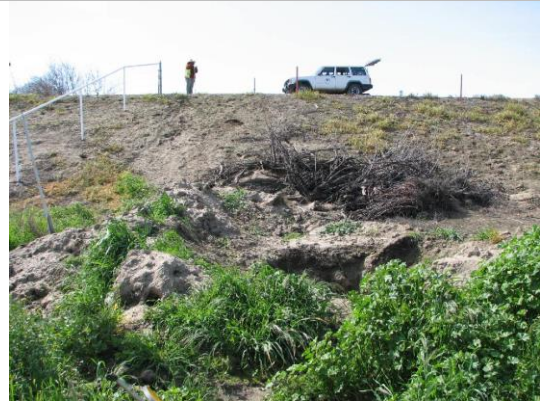
Photo 1 of 3 : UCIP_SP_2018_52587_72215.jpg

FS_ID:52587
DS_ID:34
EP_NO: 15117
Repair Type: Non-Urgent
Crossing Status: Found
UCIP Comments: 12/01/2017 Supporting documentation (field report) was received from KSN, Inc, R. Toy, addressing the repair of the leaking pipe and levee slope at this location. Compaction tests associated with the repair have not been received -- need to coordinate with CVFPB, LMA, and DWR Inspector. (DWR UCIP - O. Magana)07/12/2016 Crossing has been downgraded from Urgent to Non-Urgent--LS levee slope repaired. Levee slope was disturbed to repair leaky pipe--LS splice approximately 20-30 feet off the LS toe. Need to contact owner to determine if any documentation is available to support repair extent or internal integrity inspection of pipe through levee. (DWR UCIP - omagana)02/04/2010 Section of landward slope exposed--Need to contact owner to address cut on levee and determine status of crossing. Dense vegetation limits the inspector's visibility to identify signs of pipe failure (leaks) along the slope. Recommend removing vegetation along pipe alignment to conduct proper inspection of structure. (DWR UCIP - omagana)

FIELD_STRUCT_DESC: 10-inch steel irrigation pipe through levee, 3.43-feet below the levee crown. Siphon breaker is located on the waterside (WS) shoulder. Pump is located approximately 100 feet from the landside (LS) toe. Ramp is located on the LS slope. (10-inch installed and existing 8-inch pipe removed under Permit No. 15117, 1989 - Rio Blanco Ranch, Inc.; 10-inch pipe was installed as part of the re-shaping of RD17 project levees in 1989. The re-shaping of the levees was to increase levee elevations and provide freeboard above 100-year stages in both the San Joaquin River and French Camp Slough; work was authorized and documented under Permit No. 15014, 1989 - Reclamation District [RD0017]) [Additional Reference(s): DWR Levee Log, 1981 and 2003]
FS Date: 12/1/2017 9:41:00 AM

View of LS.

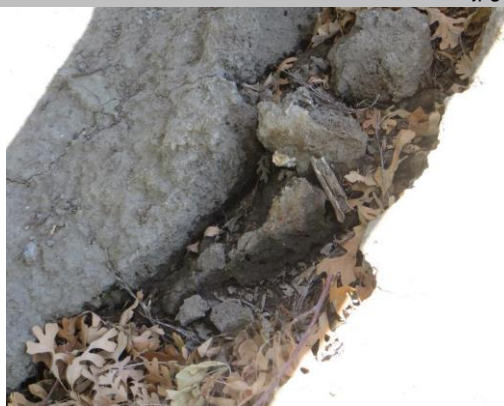
Photo 2 of 3 : UCIP_SP_2018_45998_74485.jpg

Comment Code						
Inspector Comment						
FS_ID:45998 DS_ID:35 EP_NO: 15118 Repair Type: Non-Urgent Crossing Status: Found UCIP Comments: 05/19/2015 Erosion is still present on waterward side--wet soil along pipe alignment (where pipe section is exposed). Burrow activity is also present at this location. Recommend contacting owner to address burrow activity. 02/04/2010 Erosion visible on waterward side visible at pipe daylight. Need to contact owner to address potential pipe failure. Need to determine status of crossing. FIELD_STRUCT_DESC: 14-inch steel irrigation pipe through levee, 3.32 feet below levee crown. Siphon breaker on landside (LS) shoulder. Pump on platform in channel, wooden walkway extends from pump platform to waterside (WS) slope, concrete stairway extends from walkway to WS shoulder and a standpipe is located 2 feet from the LS toe. (14-inch pipe installed and existing 12-inch pipe removed under Permit No. 15118, 1989 - L. Matlock) [Additional Reference(s): DWR Levee Logs, 1981 and 2003] FS Date: 5/19/2015

(2015) Wet ground along pipe alignment on waterward side.

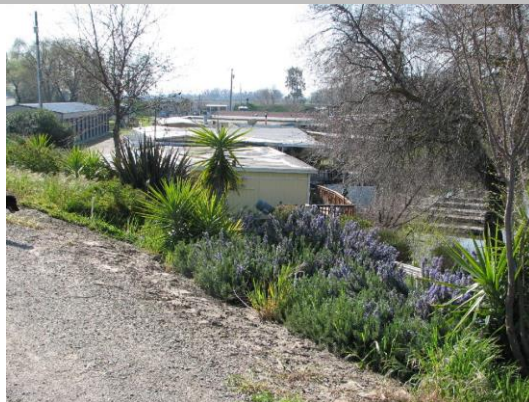
Photo 2 of 3 : UCIP_SP_2018_40669_72238.jpg

Comment Code						
Inspector Comment						
FS_ID:40669 DS_ID:36 EP_NO: 15119 Repair Type: Non-Urgent Crossing Status: Found UCIP Comments: Need to contact owner to determine status. FIELD_STRUCT_DESC: 16-inch steel irrigation pipe through levee, 1.33 feet below levee crown. Slant pump on riverbank, standpipe located 30 feet from the landside (LS) toe. Ramp on waterside (WS) slope. (16-inch pipe authorized under Permit No. 15119, 1990 - J. J. Lawrence, et al; 16-inch pipe was part of the levee work approved under Permit No. 15014, 1990 - Reclamation District 17 [RD0017]) [Additional Reference(s): DWR Levee Logs, 1981 and 2003] FS Date: 2/4/2010

View of waterward side.

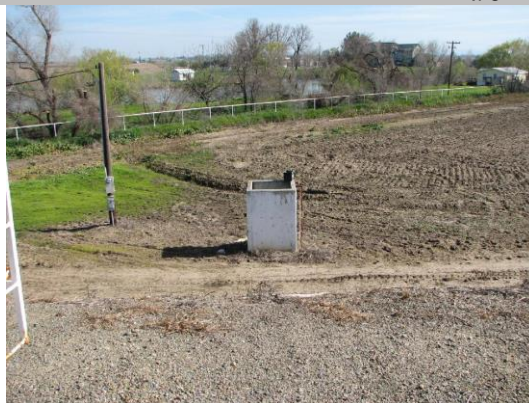
Photo 3 of 3 : UCIP_SP_2018_40669_72237.jpg

Comment Code						
Inspector Comment						
FS_ID:40669 DS_ID:36 EP_NO: 15119 Repair Type: Non-Urgent Crossing Status: Found UCIP Comments: Need to contact owner to determine status. FIELD_STRUCT_DESC: 16-inch steel irrigation pipe through levee, 1.33 feet below levee crown. Slant pump on riverbank, standpipe located 30 feet from the landside (LS) toe. Ramp on waterside (WS) slope. (16-inch pipe authorized under Permit No. 15119, 1990 - J. J. Lawrence, et al; 16-inch pipe was part of the levee work approved under Permit No. 15014, 1990 - Reclamation District 17 [RD0017]) [Additional Reference(s): DWR Levee Logs, 1981 and 2003] FS Date: 2/4/2010

Distribution box located on landward side.

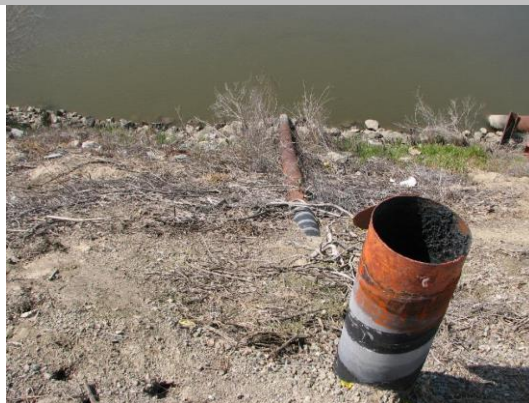
Photo 2 of 3 : UCIP_SP_2018_40672_72267.jpg

Comment Code						
Inspector Comment						
FS_ID:40672						
DS_ID:38						
EP_NO: 15121						
Repair Type: Non-Urgent						
Crossing Status: Found						
UCIP Comments: Pipe section at waterward toe is missing wall. Need to coordinate with owner to determine integrity of pipe section through levee. This crossing is a good candidate for video inspection to determine internal condition of pipe.						
FIELD_STRUCT_DESC: 10-inch steel drainage through the levee, 4 feet below crown. (10-inch pipe authorized under Permit No. 15121, 1989 - R. Muller, additional work also includes removal of 12-inch and two 9-inch pipes at different locations and installation of a 12-inch pipe; 10-inch pipe was installed during the levee work approved under Permit No. 15014, 1989-Reclamation District [RD0017]) [Additional Reference(s): DWR Levee Logs, 1981 and 2003]						
FS Date: 2/4/2010

View of waterward side.

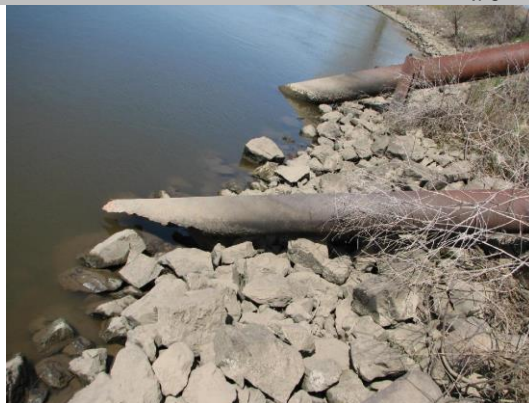
Photo 3 of 3 : UCIP_SP_2018_40672_72271.jpg

Comment Code						
Inspector Comment						
FS_ID:40672						
DS_ID:38						
EP_NO: 15121						
Repair Type: Non-Urgent						
Crossing Status: Found						
UCIP Comments: Pipe section at waterward toe is missing wall. Need to coordinate with owner to determine integrity of pipe section through levee. This crossing is a good candidate for video inspection to determine internal condition of pipe.						
FIELD_STRUCT_DESC: 10-inch steel drainage through the levee, 4 feet below crown. (10-inch pipe authorized under Permit No. 15121, 1989 - R. Muller, additional work also includes removal of 12-inch and two 9-inch pipes at different locations and installation of a 12-inch pipe; 10-inch pipe was installed during the levee work approved under Permit No. 15014, 1989-Reclamation District [RD0017]) [Additional Reference(s): DWR Levee Logs, 1981 and 2003]						
FS Date: 2/4/2010

Pipe section inside wall has completely corroded--wall missing.

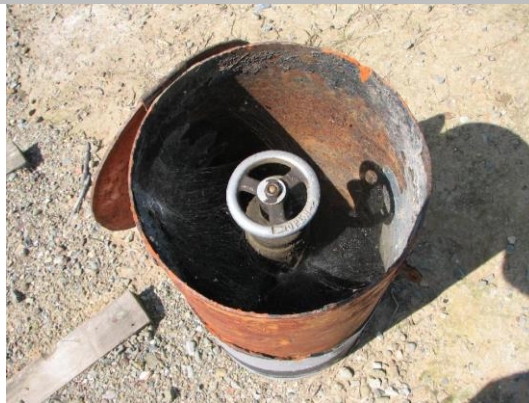
Photo 2 of 3 : UCIP_SP_2018_40677_72294.jpg

Comment Code						
Inspector Comment						
FS_ID:40677 DS_ID:40 EP_NO: 15123 Repair Type: Non-Urgent Crossing Status: Found UCIP Comments: Landowner mentioned power line was stolen crossing was non-functional during inspection. Potential erosion underneath walkway--need to confirm lose soil. Need to contact owner to determine status of crossing. If crossing is no longer used need to coordinate with CVFPB for proper abandonment. FIELD_STRUCT_DESC: 16-inch steel irrigation pipe through levee, 2.70 feet below the levee crown. Siphon breaker on waterside (WS) shoulder. Ramp on platform in channel, walkway from pump platform to WS slope, standpipe located at landside (LS) berm toe. (16-inch pipe installed and authorized under Permit No. 15123-1989, also includes removal of two existing pipes, 8-inch and 10-inch) [Additional Reference(s): DWR Levee Logs, 1981 and 2003] FS Date: 2/4/2010

Siphon breaker located on waterward side.

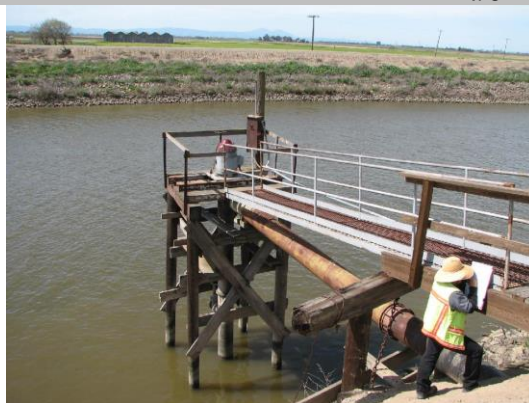
Photo 3 of 3 : UCIP_SP_2018_40677_72292.jpg

Comment Code						
Inspector Comment						
FS_ID:40677 DS_ID:40 EP_NO: 15123 Repair Type: Non-Urgent Crossing Status: Found UCIP Comments: Landowner mentioned power line was stolen crossing was non-functional during inspection. Potential erosion underneath walkway--need to confirm lose soil. Need to contact owner to determine status of crossing. If crossing is no longer used need to coordinate with CVFPB for proper abandonment. FIELD_STRUCT_DESC: 16-inch steel irrigation pipe through levee, 2.70 feet below the levee crown. Siphon breaker on waterside (WS) shoulder. Ramp on platform in channel, walkway from pump platform to WS slope, standpipe located at landside (LS) berm toe. (16-inch pipe installed and authorized under Permit No. 15123-1989, also includes removal of two existing pipes, 8-inch and 10-inch) [Additional Reference(s): DWR Levee Logs, 1981 and 2003] FS Date: 2/4/2010

View of waterward side.

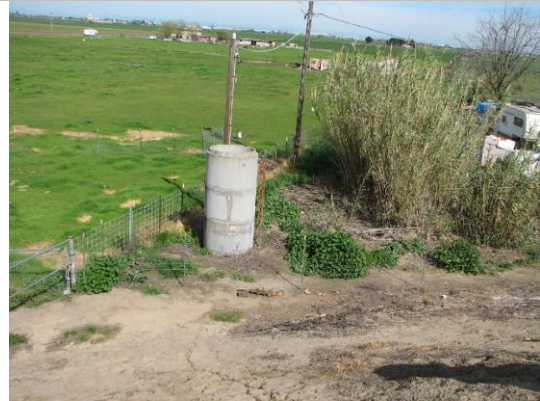
Photo 3 of 3 : UCIP_SP_2018_40679_72305.jpg

Comment Code						
Inspector Comment						
FS_ID:40679 DS_ID:42 EP_NO: 15077 Repair Type: Non-Urgent Crossing Status: Found UCIP Comments: Surface erosion on waterward slope. Abandoned pipe section left on waterward slope. Need to contact owner to obtain additional information about crossing. FIELD_STRUCT_DESC: 12-inch steel irrigation pipe through levee. Invert of pipe 3.67 feet below levee crown. Siphon breaker on landside (LS) shoulder. Pump on platform in channel, walkway from pump platform to waterside (WS) shoulder. Standpipe located 15 feet from the LS toe. (12-inch pipe authorized under Permit No. 15077, 1989 - J. P. Leal, existing 12-inch pipe removed) [Additional Reference(s): DWR Levee Logs, 1981 and 2003, 12-inch pipe] FS Date: 2/4/2010

Standpipe visible on landward toe.

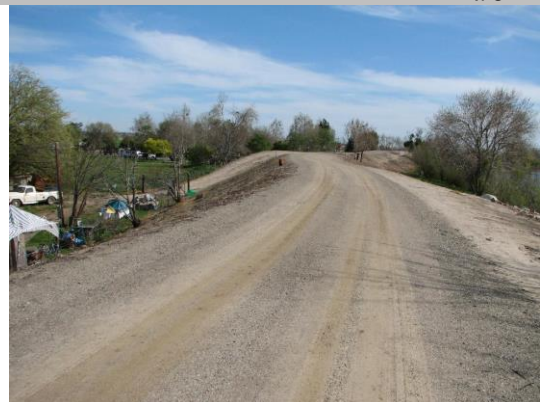
Photo 1 of 3 : UCIP_SP_2018_40680_72314.jpg

Comment Code					
Inspector Comment					
FS_ID:40680 DS_ID:43 EP_NO: 15078 Repair Type: Non-Urgent Crossing Status: Found UCIP Comments: Crossing is non-functional recommend contacting owner to determine status of crossing. If crossing is no longer used need to coordinate with CVFPB for proper abandonment. FIELD_STRUCT_DESC: 4-inch irrigation pipe of unknown material through levee, 2.89 feet below levee crown. Siphon breaker on landside (LS) shoulder. Pump on waterside (WS) berm. (4-inch pipe authorized under Permit No. 15078, 1989 - S. and F. Aurelio, existing 4-inch pipe removed) [Additional Reference(s): DWR Levee Logs, 1981 and 2003] FS Date: 2/4/2010

Overview of levee crown at crossing.

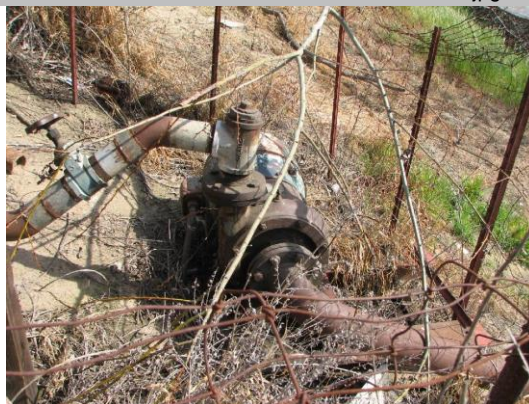
Photo 3 of 3 : UCIP_SP_2018_40680_72316.jpg

Comment Code						
Inspector Comment						
FS_ID:40680						
DS_ID:43						
EP_NO: 15078						
Repair Type: Non-Urgent						
Crossing Status: Found						
UCIP Comments: Crossing is non-functional recommend contacting owner to determine status of crossing. If crossing is no longer used need to coordinate with CVFPB for proper abandonment.						
FIELD_STRUCT_DESC: 4-inch irrigation pipe of unknown material through levee, 2.89 feet below levee crown. Siphon breaker on landside (LS) shoulder. Pump on waterside (WS) berm. (4-inch pipe authorized under Permit No. 15078, 1989 - S. and F. Aurelio, existing 4-inch pipe removed) [Additional Reference(s): DWR Levee Logs, 1981 and 2003]						
FS Date: 2/4/2010

Motor located on waterward slope.

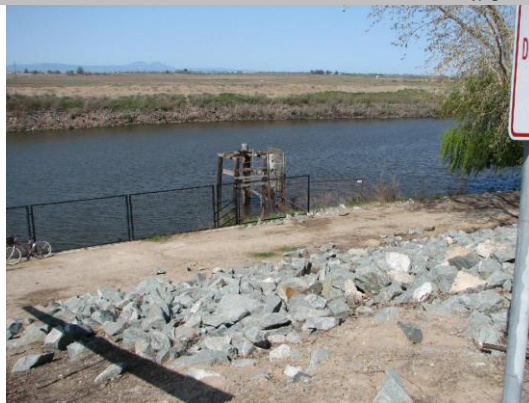
Photo 1 of 3 : UCIP_SP_2018_40681_72325.jpg

FS_ID:40681
DS_ID:44
EP_NO: 15079
Repair Type: Non-Urgent
Crossing Status: Found
UCIP Comments: If crossing is no longer in use owner will need to coordinate with DWR inspector and CVFPB to remove according to Title 23 requirements. Unable to determine if crossing is in use.
FIELD_STRUCT_DESC: 14-inch steel irrigation pipe through levee, 1.17 feet below levee crown. Siphon breaker on waterside (WS) shoulder. Pump on platform in channel, walkway from pump platform to the top of the riverbank, standpipe located 12 feet from landside (LS) toe. (14-inch pipe installed under Permit No. 15079-1990 - San Joaquin County Parks and Joe P. Aven, authorized work also include installation of 10-inch pipe in general area and the removal of two existing pipes, 10-inch pipe and 6-inch pipe) [Additional Reference(s): DWR Levee Logs, 1981 and 2003]
FS Date: 2/4/2010

View of waterward side.

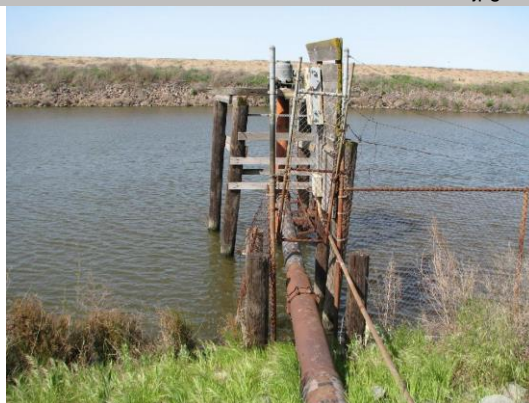
Photo 2 of 3 : UCIP_SP_2018_40681_72328.jpg

Pipe, pump, and platform located on waterward side.
